MICROSCOPIC INTERNAL FLAWS INDUCING FRACTURE IN STEEL.

THOMAS ANDREWS, F.R.S., F.C.S., M. Inst. C.E.

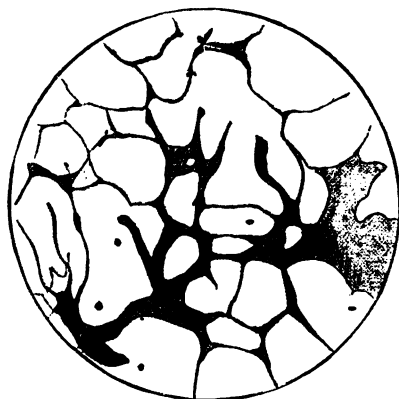
FIG. 1. Internal Micro-Flaw $\times 250$; carbon 0.10 per cent., sulphur 2.0 per cent.

Illustrations of typical internal micro-flaws solely due to the presence of excess of sulphur in iron or steel will be seen on reference to the micro-sections, Figs. 1, 2, and 3, pp. 4, 5. These flaws were due entirely to the presence of excess of sulphur purposely alloyed in samples of pure iron made by Professor J. O. Arnold, F.C.S., Sheffield Technical School. The analysis of the metal in which these sulphur flaws were found was as follows: The sample from which micro-section Fig. 1, page 4, was taken contained iron 97.90 per cent.; combined carbon, 0.10 per cent.; sulphur, 2.00 per cent. The samples from which the micro-sections Figs. 2 and 3, pp. 4, 5, were taken contained iron about 99.65 per cent., combined carbon, 0.10 per cent.; sulphur, 0.25 per cent. The incipient micro-flaws due to sulphur in these samples varied in size from about 0.018 in. in length, and in thickness from about 0.001 in., tapering down to as small as 0.00001 in.

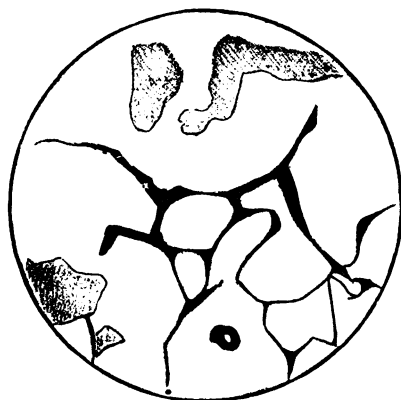
FIG. 2. Internal Micro-Flaws $\times 300$; sulphur 0.25 per cent.

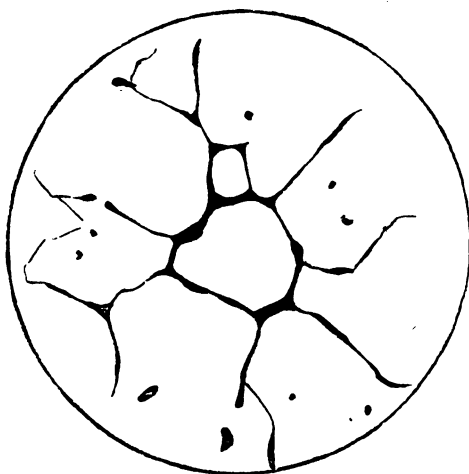
FIG. 3. Internal Sulphur Flaws $\times 300$ diameter.

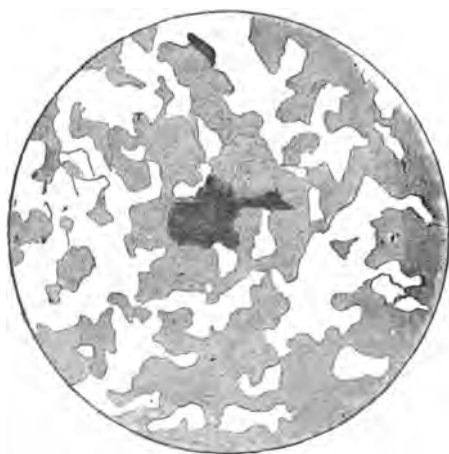
FIG. 4. Bessemer Steel Railway Axle, showing Internal Micro-Flaws $\times 500$ diameter.

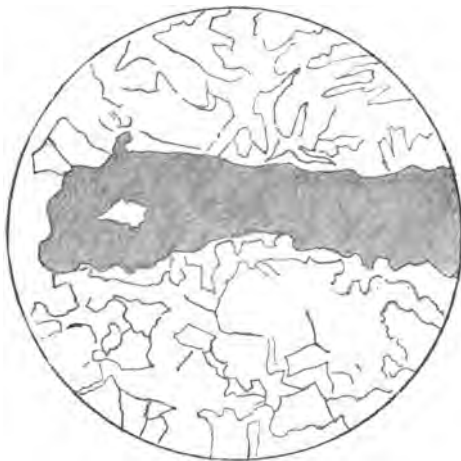
FIG. 5. Internal Flaw $\times 300$ diameter, Bessemer Steel Railway Axle 2.

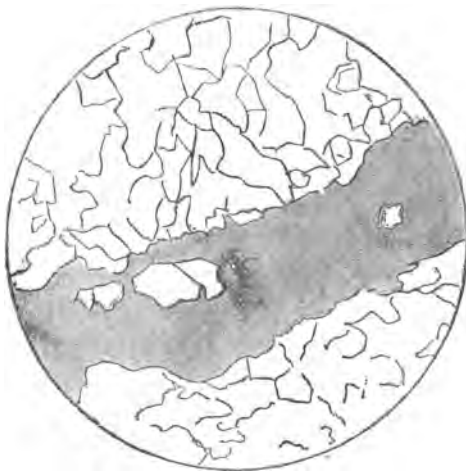
FIG. 6. Bessemer Steel Railway Axle, Internal Flaw $\times 300$ diameter.

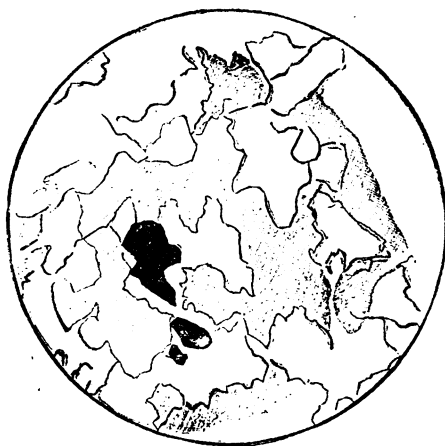
FIG. 7. Internal Micro-Flaws, Belgian Bessemer Steel Railway Axle, $\times 800$ diameter.

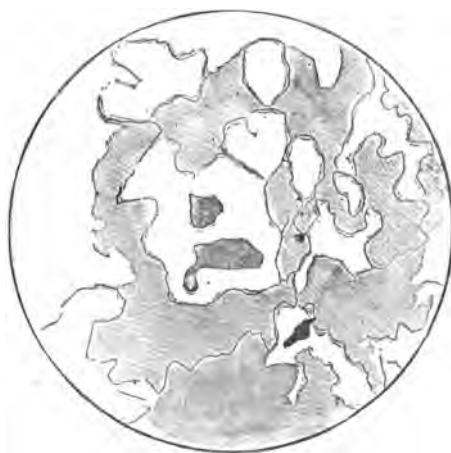
FIG. 8. Internal Micro-Flaws, Belgian Bessemer Steel Railway Axle, $\times 800$ diameter.

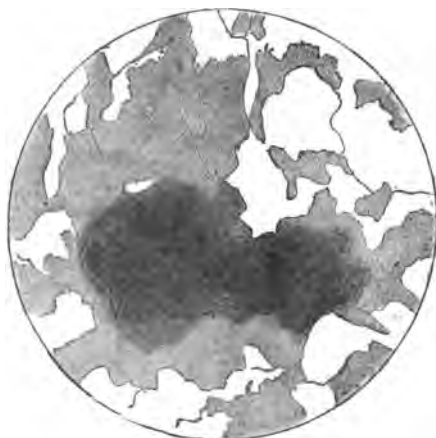
FIG. 9. Siemens Steel (W.S.) Railway Axle, Internal Micro-Flaws, $\times 300$ diameter.

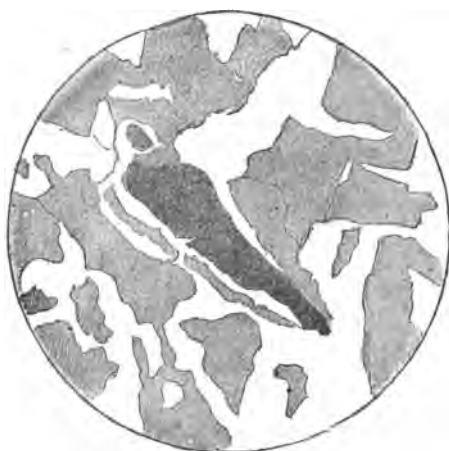
FIG. 10. Siemens Steel Railway Axle, showing Internal Micro-Flaws, $\times 500$ diameter.

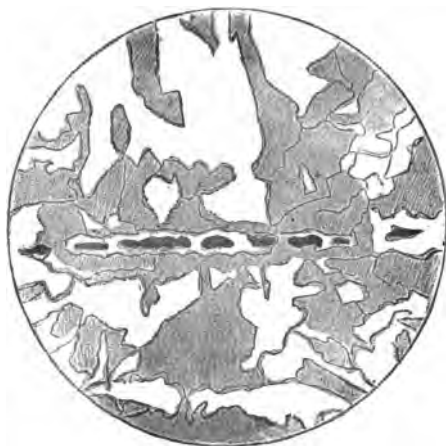
FIG. 11. Siemens Steel Railway Axle, showing Internal Micro-Flaws, $\times 300$ diameter.

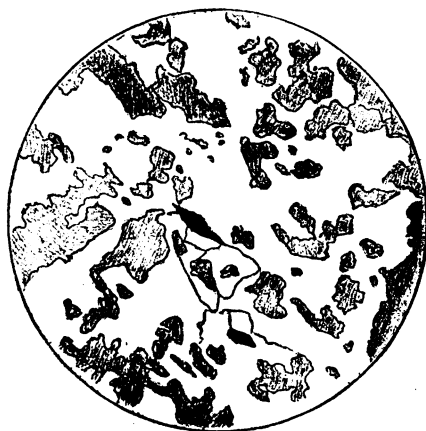
FIG. 12. Siemens Steel Locomotive Crank Axle, showing Internal Micro-Flaws, $\times 300$ diameter.

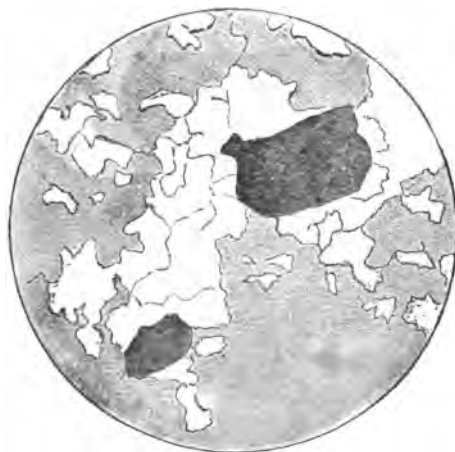
FIG. 13. English Bessemer Steel Railway Tyre, Internal Micro-Flaws, $\times 400$ diam.

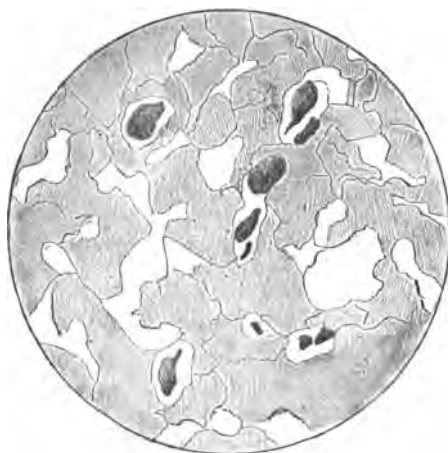
FIG. 14. Siemens Steel Railway Tyre, showing Internal Micro-Flaws, $\times 500$ diam.

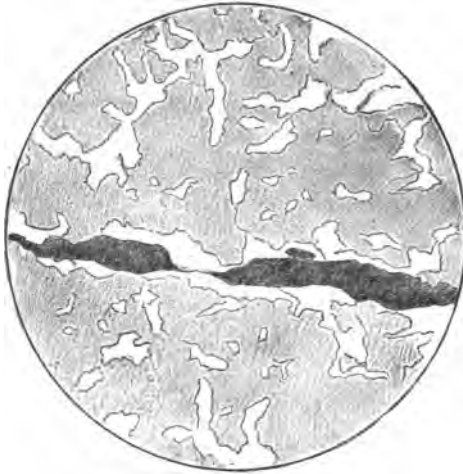
FIG. 15. Bessemer Steel Rail, 86 lb. per yard, showing Internal Micro-Flaws, $\times 300$ diameter.

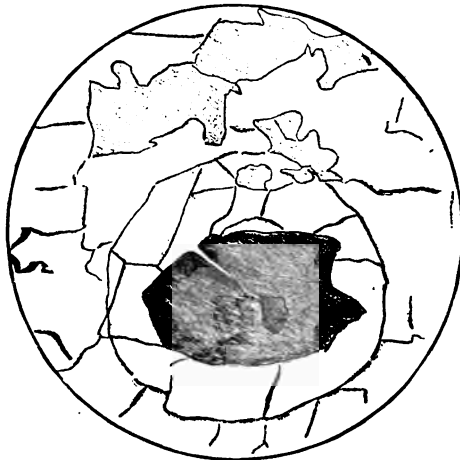
FIG. 16. Siemens Steel Propeller Shaft, Internal Micro-Flaw, $\times 500$ diameter.

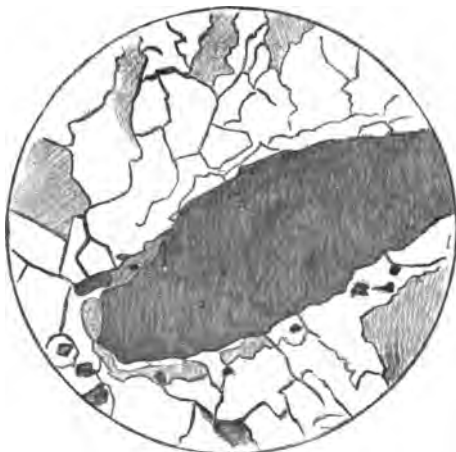
FIG. 17. Internal Micro-Flaw, Siemens Steel Propeller Shaft, $\times 300$ diameter.

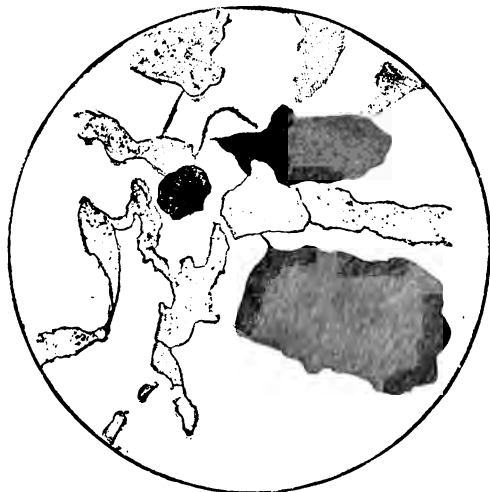
FIG. 18. Internal Micro-Flaws, Siemens Steel Propeller Shaft, $\times 800$ diameter.

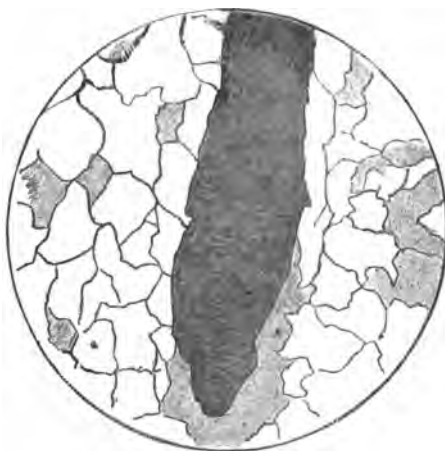
FIG. 19. Internal Micro-Flaw, Siemens Steel (Warship) Propeller Shaft, $\times 300$ diam.

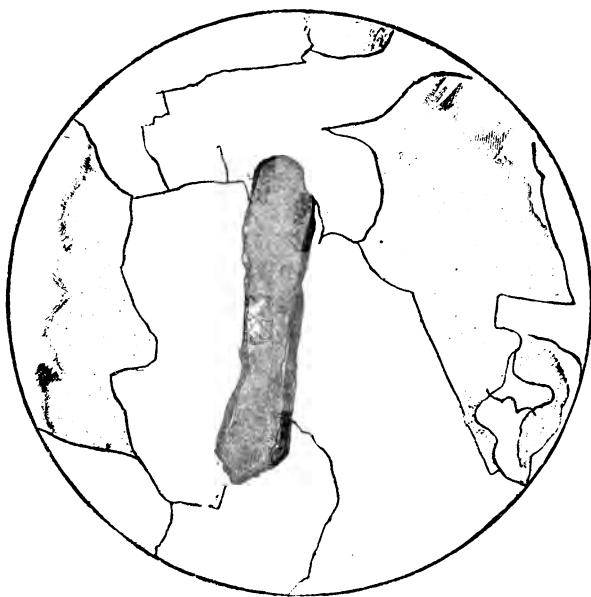
FIG. 20. Internal Micro-Flaw, Siemens Steel Propeller Crankshaft, $\times 800$ diam.

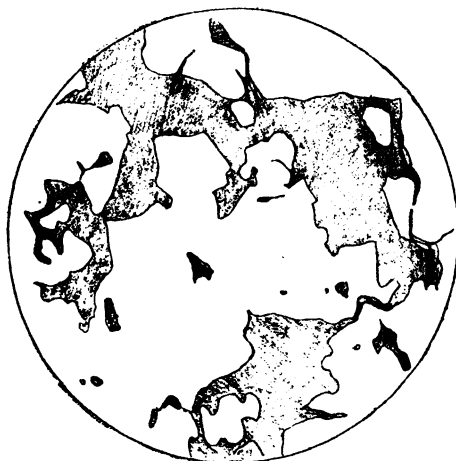
FIG. 21. Internal Micro-Flaws, Siemens (soft) Steel Shaft, $\times 300$ diameter.

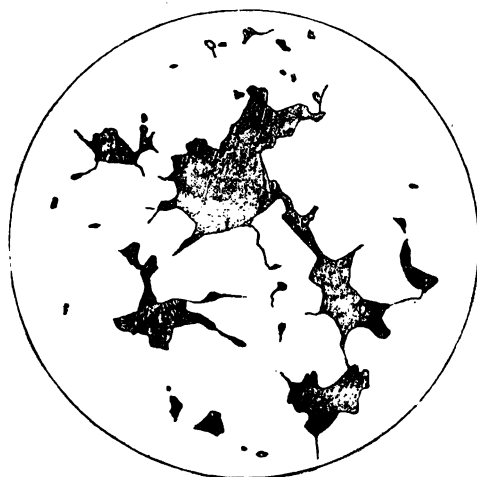
FIG. 22. Internal Micro-Flaws, Siemens (soft) Steel Shaft, $\times 300$ diameter.

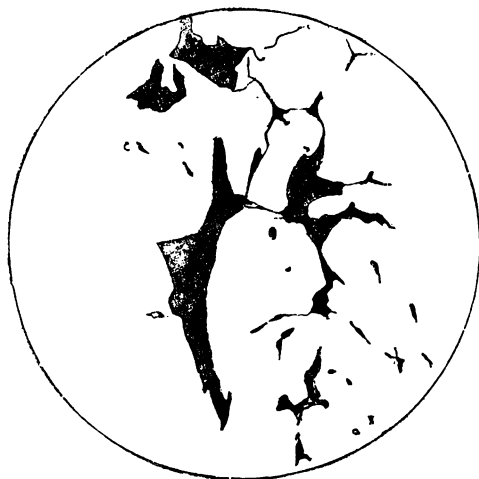
FIG. 23. Internal Micro-Flaws, Siemens (soft) Steel Shaft, $\times 300$ diameter.

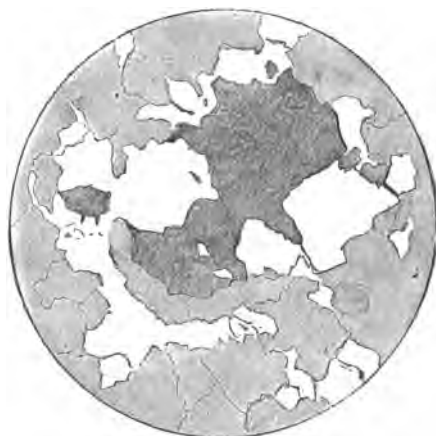
FIG. 24. Siemens (hard) Steel Shaft, Internal Micro-Flaws, $\times 300$ diameter.

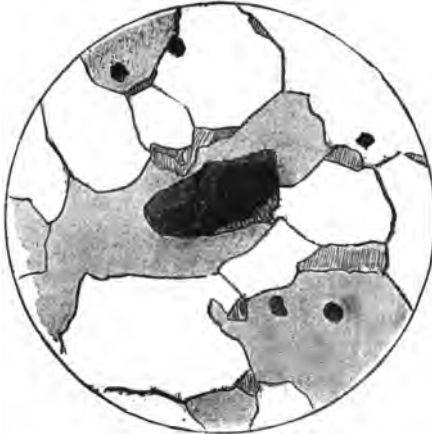
FIG. 25. Internal Micro-Flaws, Bessemer (soft) Steel Shaft (rolled), $\times 500$ diam.

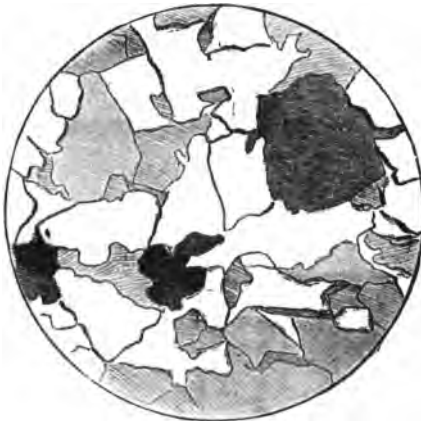
FIG. 26. Internal Micro-Flaws, Nickel Steel Shaft, $\times 500$ diameter.

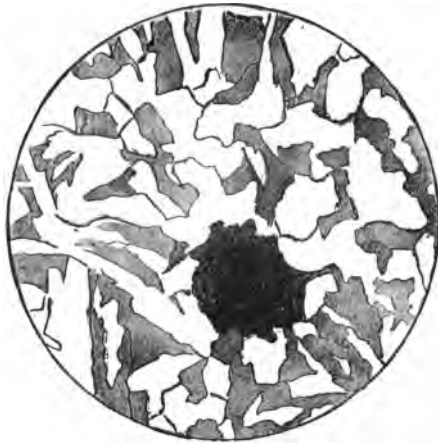
FIG. 27. Copper Steel Shaft, Internal Micro-Flaws, $\times 300$ diameter.

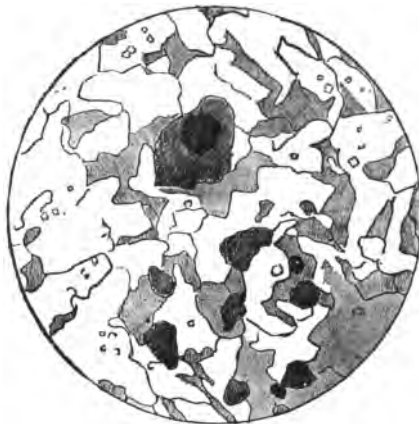
FIG. 28. Silicon Steel Shaft, Internal Micro-Flaws, $\times 300$ diameter.

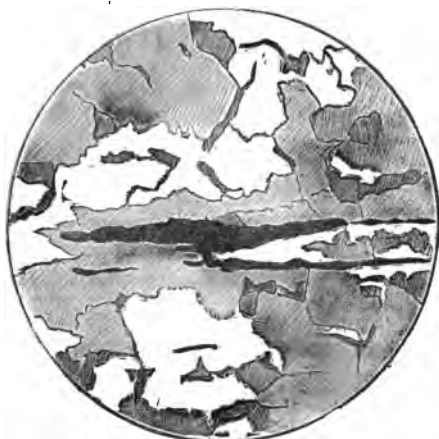
FIG. 29. Internal Micro-Flaws, Siemens Steel Ship-plate, $\times 300$ diameter.

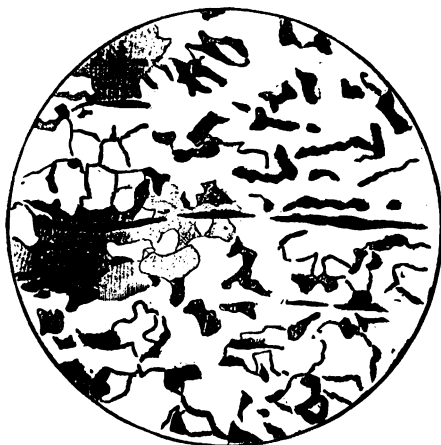
FIG. 30. Siemens Steel Boiler Plate, showing Internal Micro-Flaws, $\times 300$ diameter.
